## SUMMARY ABATEMENT ORDER AND NOTICE OF HEARING

450 N. 5<sup>th</sup> Street, San Jose, CA 95112 RE:

## INSPECTION REPORT

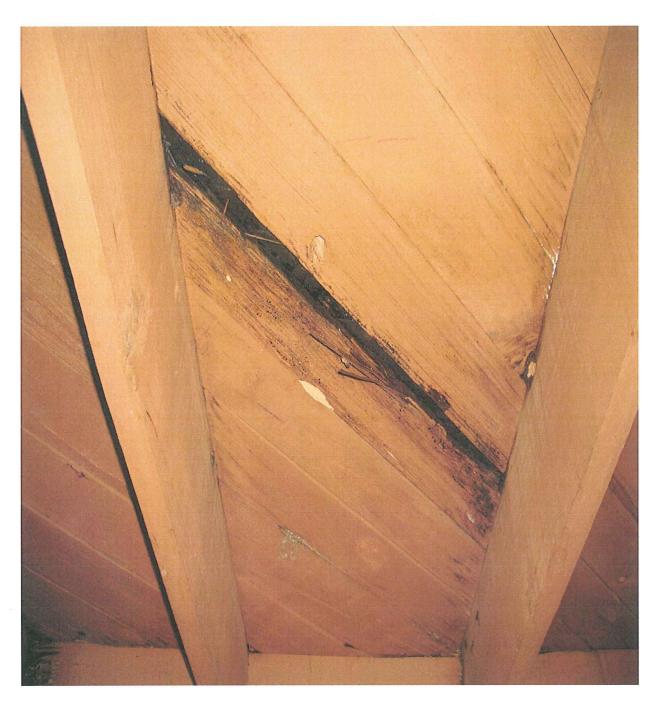
Deteriorating roof section of the carport

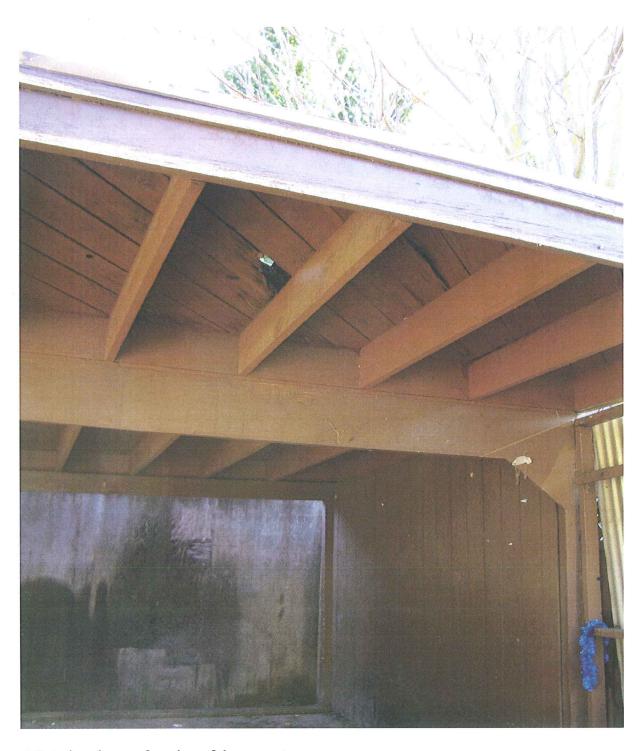
Deteriorating roof section of the carport

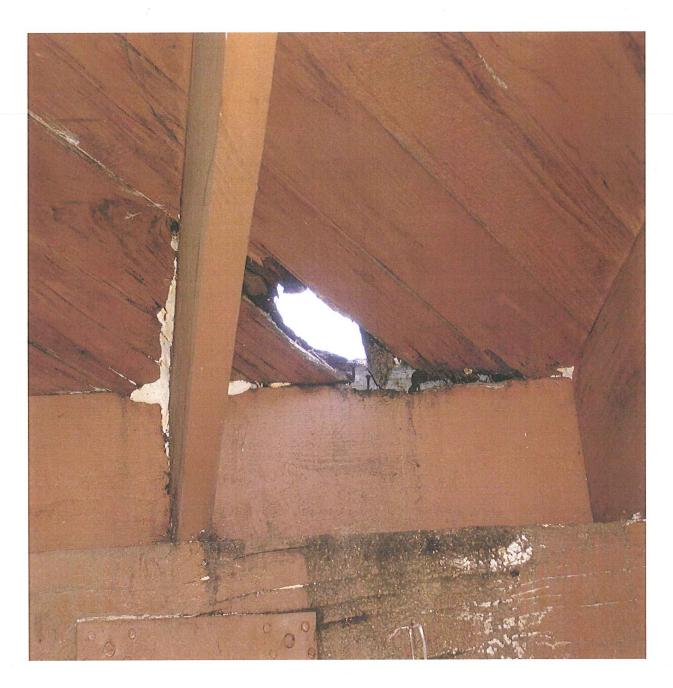
Deteriorating roof section of the carport

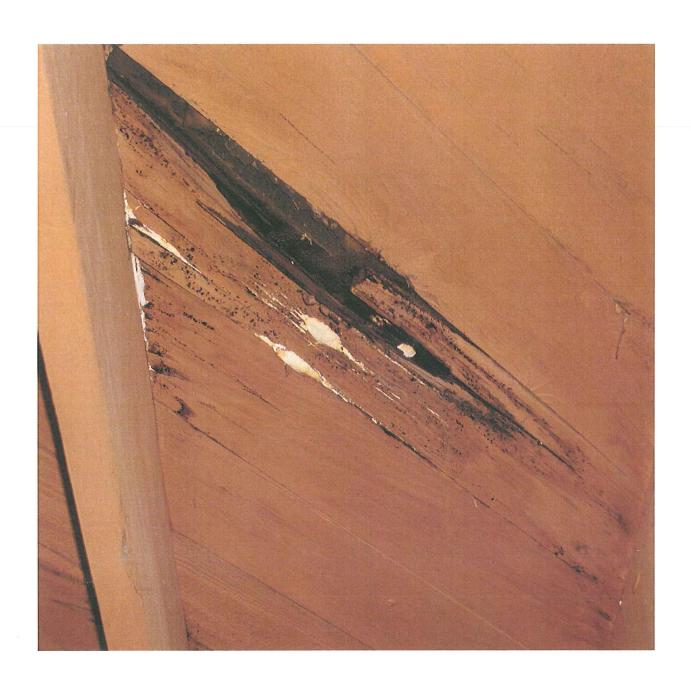
Deteriorating roof section of the carport

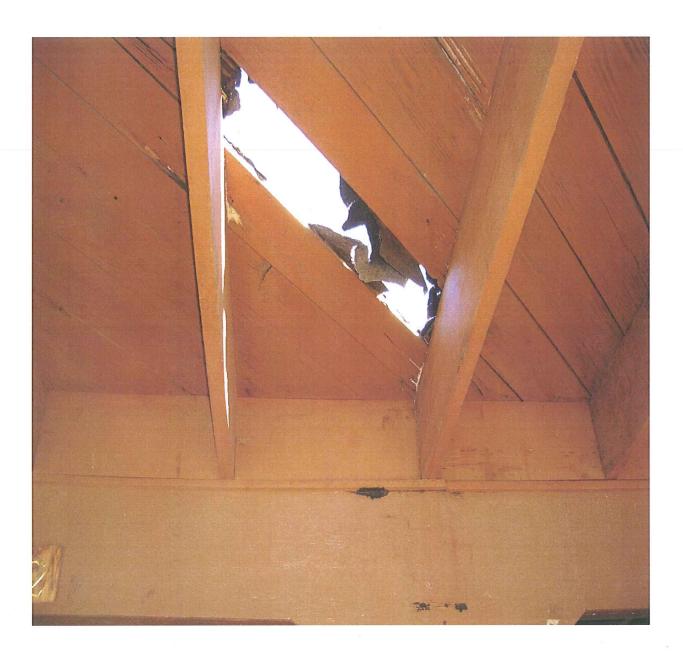
Deteriorating roof section of the carport

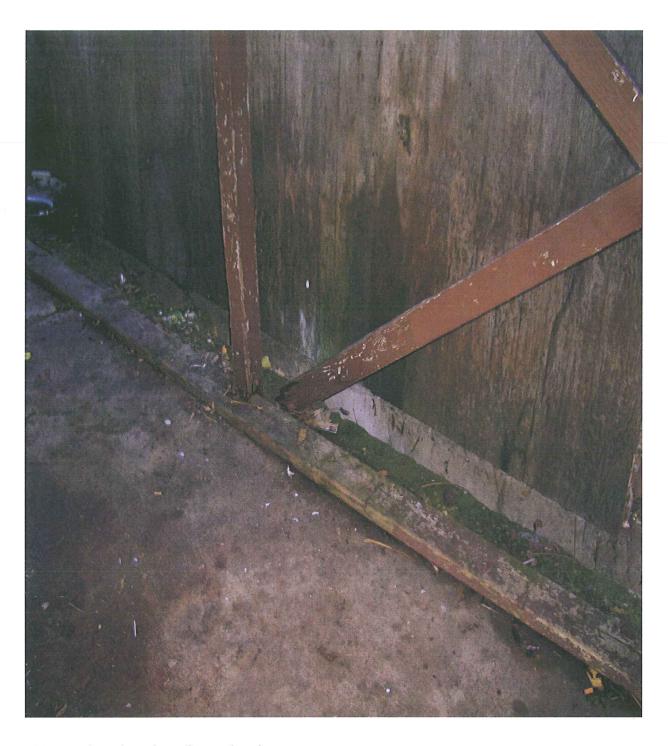
Non anchored section of cross bracing

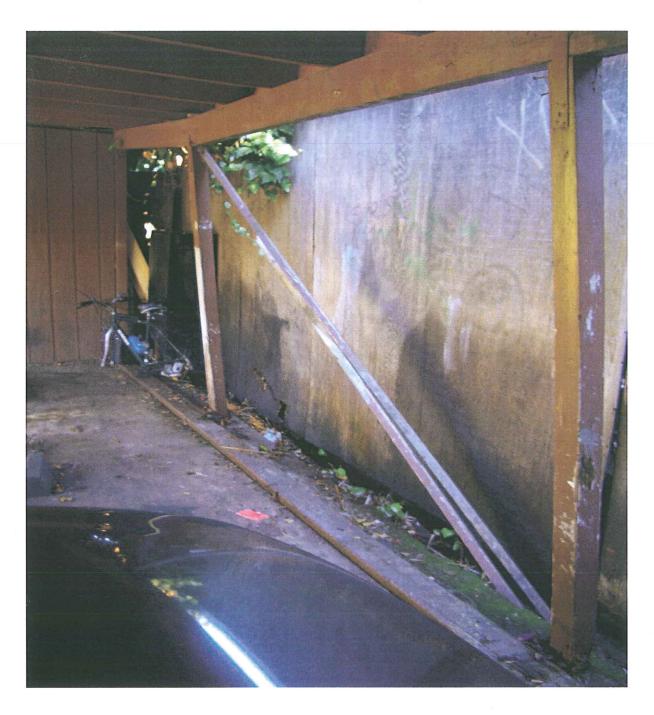
Sagging rear beam; support post/cross bracing not anchored to the footing; cross bracing not anchored to the posts; missing cross bracing

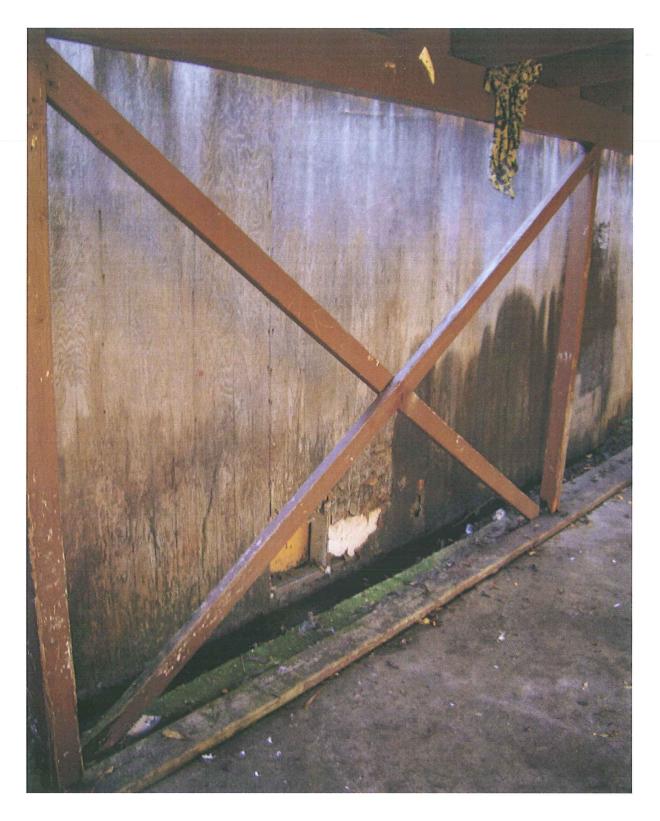
Cross bracing not anchored to the posts, support post not anchored to the footing

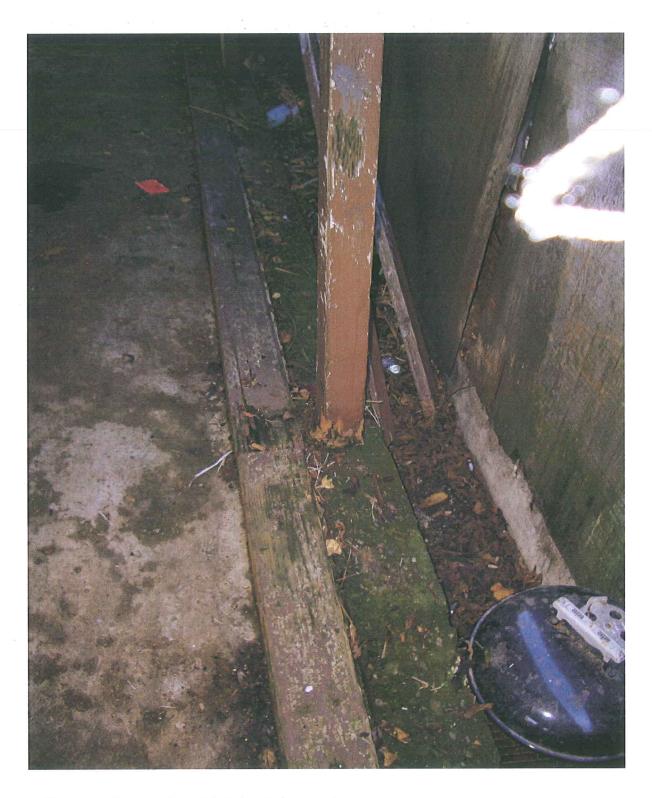
Close up of non anchored deteriorated support post

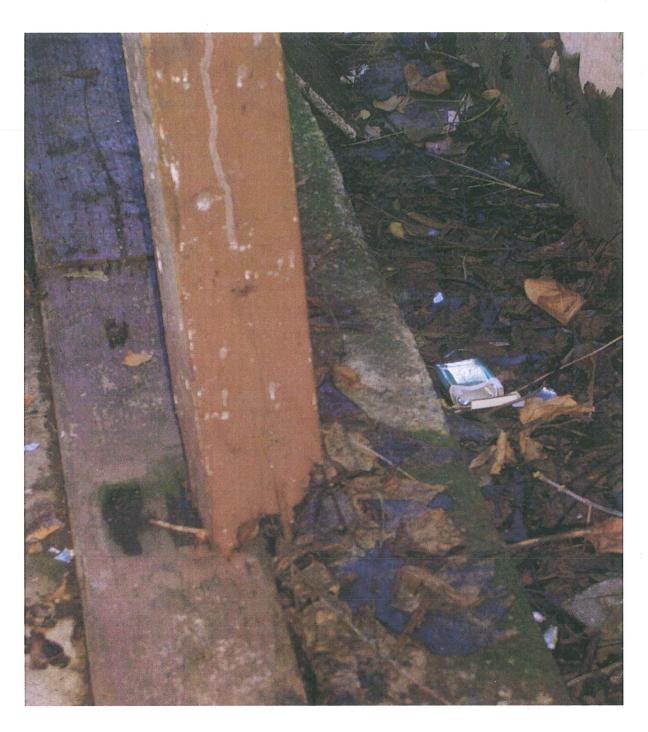
Close up of another section of a non-anchored deteriorated support post

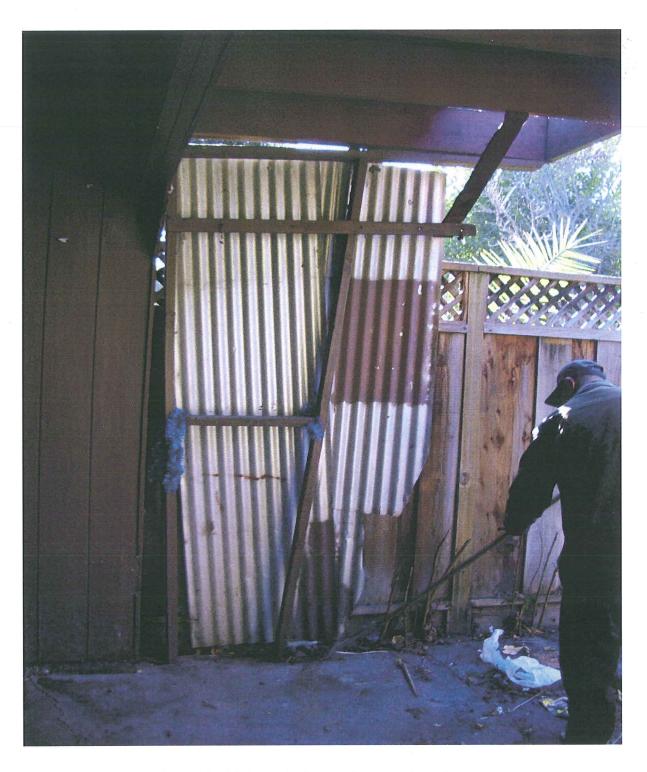
Metal corrugated side panel with jagged edges and non-anchored support post

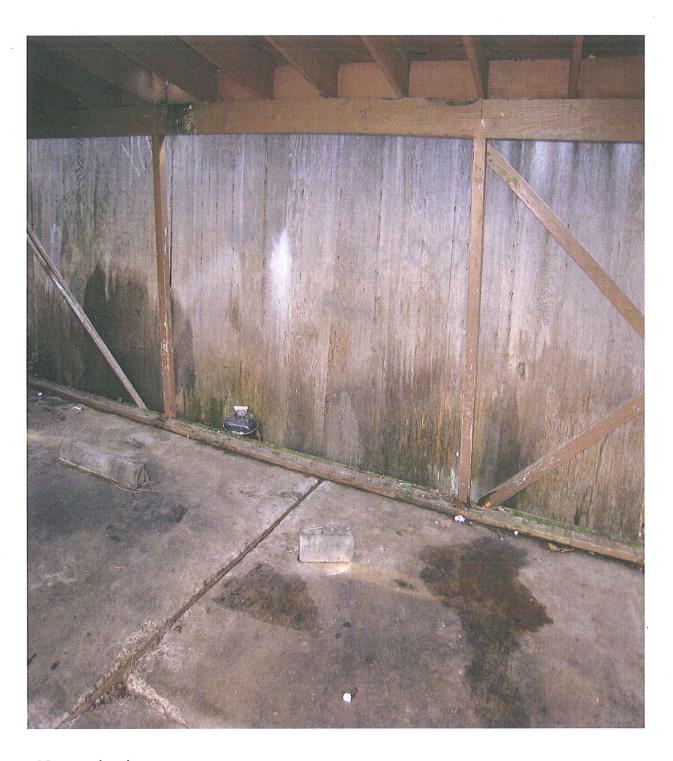
No cross bracing

deteriorating due to dry rot. Inspector Van Gastel said a building permit will be needed to repair the structure. Two (2) photographs were taken of the Subject Property. See true and correct photographs attached hereto as **Exhibit B.**

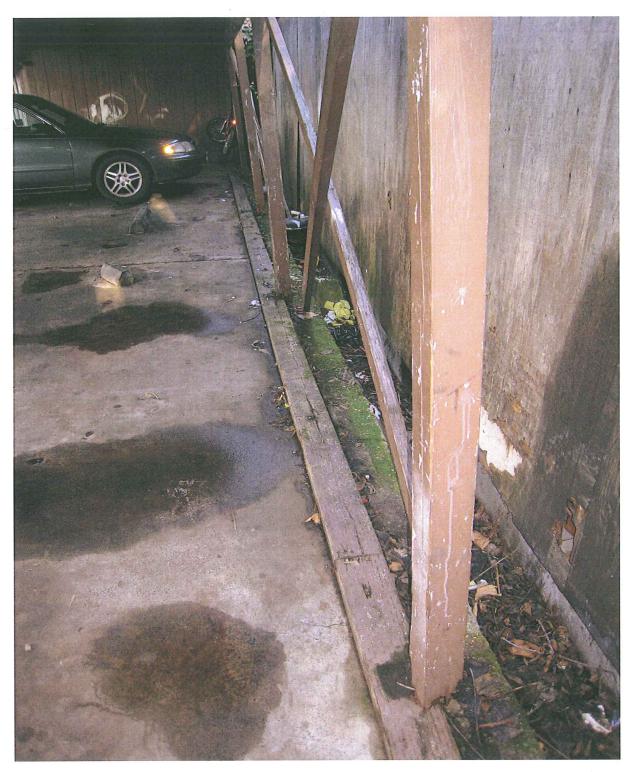
Side view of support posts/cross bracing

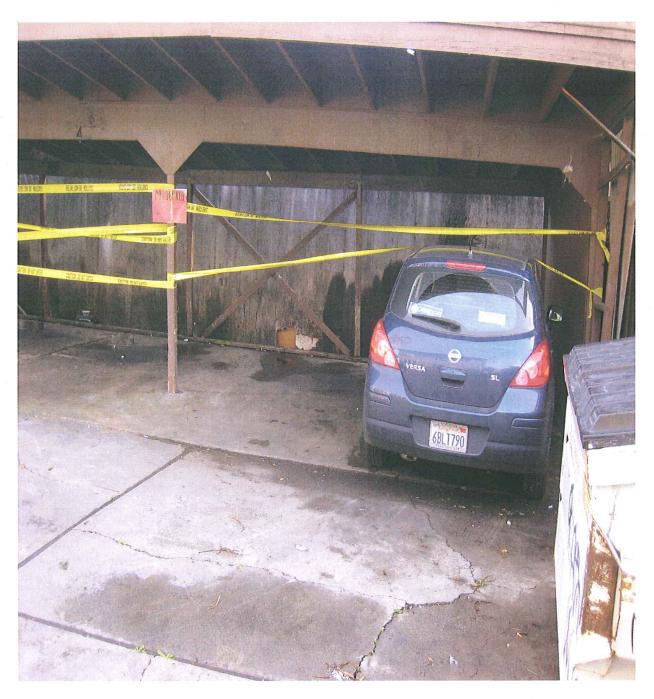
Posting of Condemn Sign and placement of caution tape

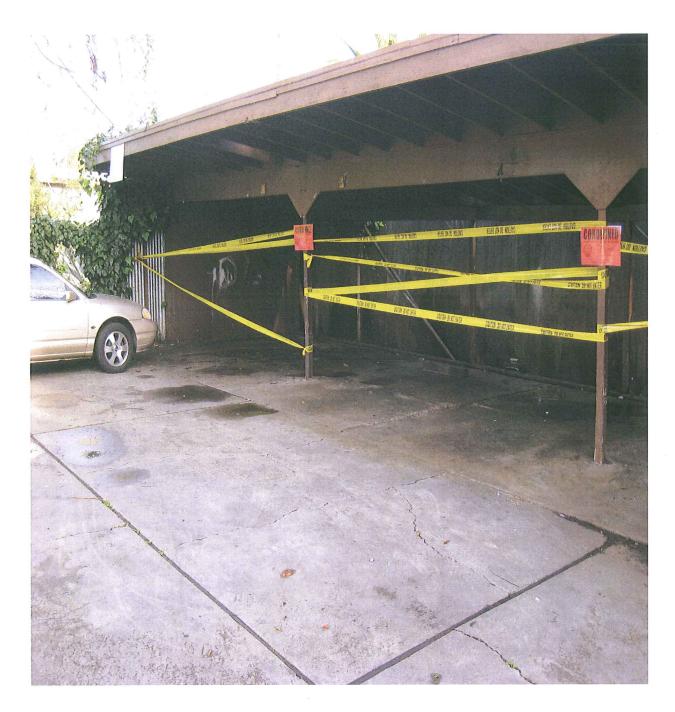
Posting of Condemn Sign and placement of caution tape
